Maggie Osgood Library Renovation

Review of Concept Option Cost Estimates

August 12, 2021

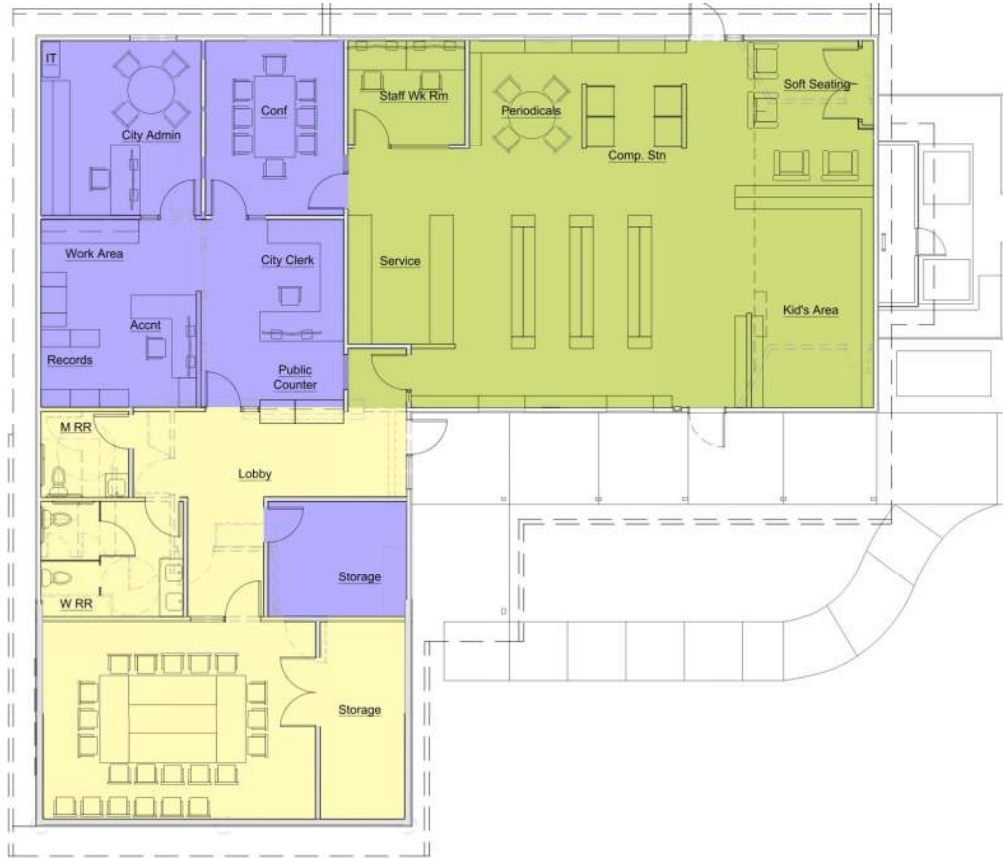
Concept Design Option 2b

3,456 sf

Improvements beyond 1b

- Carport infill.
- Revise all ductwork.
- New HVAC units.
- Upgraded elec. service.
- Replace all lights.
- New fire alarm system.
- Upgraded security system.
- Additional sidewalk.
- New pavement, north lot.

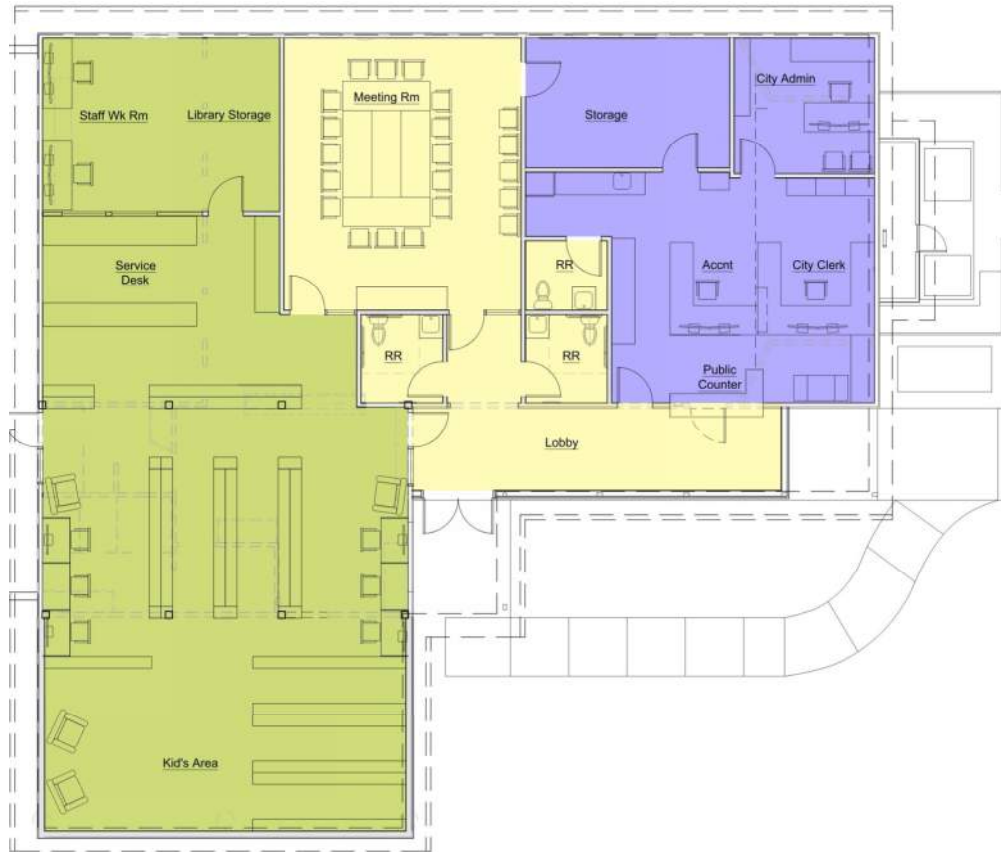
Concept Design Option 5b

3,758 sf

- Improvements beyond 2b
- Covered walkway infill.
 - Upgraded HVAC units.
 - Relocated elec. service.
 - New fire sprinklers
 - Enhanced security system.
 - Additional sidewalk.
 - New pavement, all lot.
