1. Pavement Preservation Plan

**CITY OF LOWELL**  
**Pavement**  
**Preservation Plan**

March 2019

# Pavement Preservation Plan

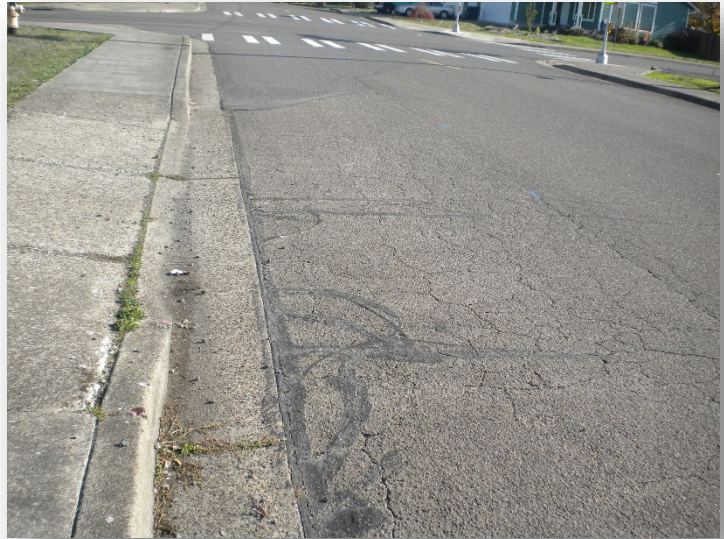
Alligator or “fatigue” cracking is a series of interconnected cracks caused by repeated traffic loading to the pavement surface. The cracks begin at the bottom layer of the pavement and eventually make their way to the surface. This allows for water to penetrate the base and sub-base layers of the pavement, causing more distress. The cracks reach the pavement surface, initially as parallel longitudinal cracks. After repeated loading, the cracks make connections to form a pattern resembling alligator skin. The cracked pieces of pavement are usually less than 1.5 feet on the longest side.

Alligator cracking is caused by traffic loading, poor sub-base or base structure, and aging pavement.

Figure 3-1 Alligator Cracking on Main St.

Typical treatment methods include: patching, 2” hot mix overlay, and chip seal. In low severity cases slurry seal or fog sealing may be recommended.

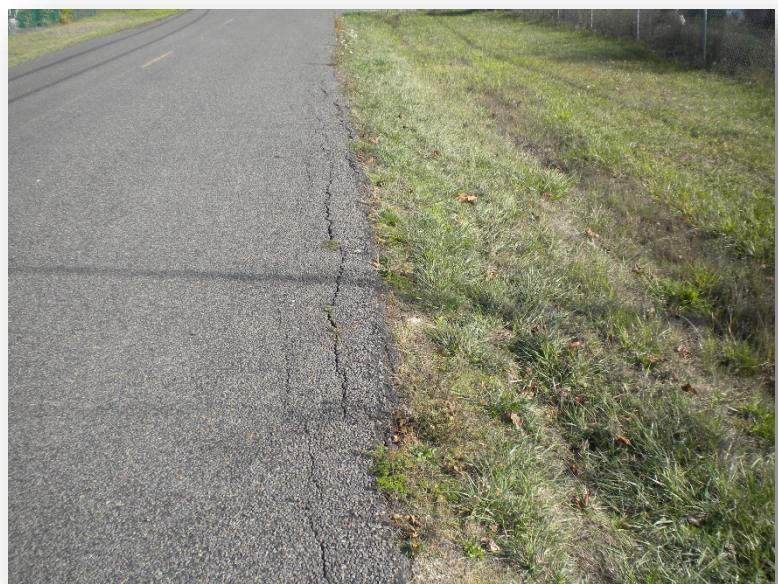
Edge cracking is a section of parallel cracks to the pavement edge. Typically seen within 1 to 1.5 feet of the outer edge of the pavement. This pavement distress is associated with traffic loading, weakened base or subgrade caused by frost heave or thaw weakening. Edge cracking at a high-severity can be classified as raveling (see section 3.2 below for more information on raveling). These cracks usually range from 1/8-inch to greater than ¼-inch.

Edge cracking is caused by traffic loading, environment, poor construction methods, and pavement shoulder deficiencies.

Figure 3-2 Edge Cracking on 2<sup>nd</sup> St.

Typical treatment methods include: crack sealing, cold mix overlay, and shoulder maintenance/reconstruction.

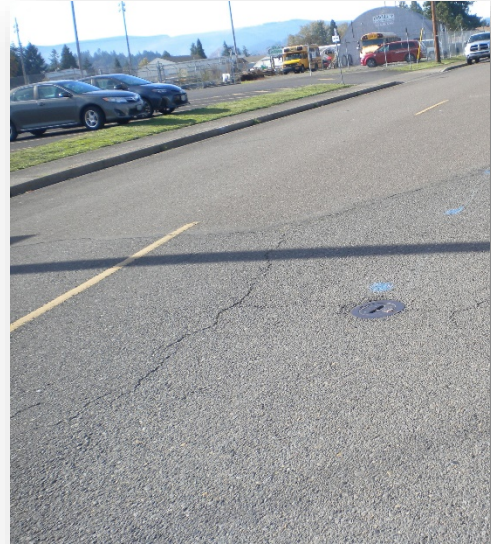
Longitudinal cracking is parallel to the pavement's centerline. Cracking may be seen anywhere along the pavement in the parallel direction. Severe longitudinal cracking can be classified as alligator cracking. Longitudinal cracks can be anywhere from 3/8-inch to 3-inches in width.

Longitudinal and Transverse cracks are usually caused by environmental impacts (freeze and thaw), swelling or shrinkage of the subgrade, poor construction methods, settlement, poor drainage and reflections cracks (cracks that occur on an overlay over an existing crack).

Figure 3-3 Longitudinal Cracking on Main St.

Typical treatment methods include crack sealing, chip seal, or patching.

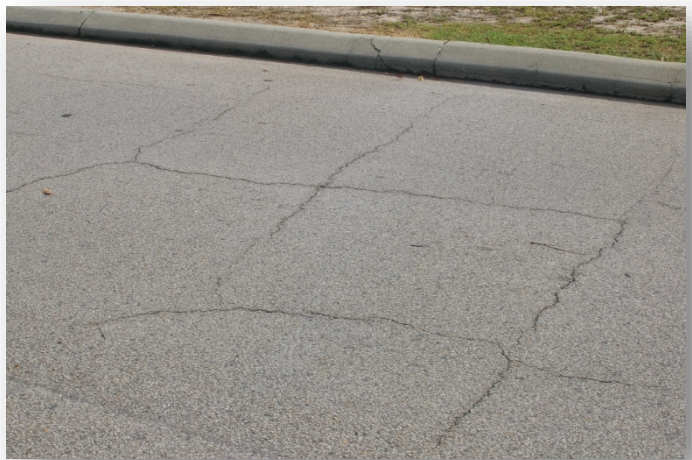
Block cracking is connected cracks creating rectangular or square cracked sections. These cracks range from an area of the size 1 by 1-foot to 10 by 10-foot sections. Block cracking is caused by the shrinkage of the asphalt and temperature change.

Block cracking is not caused by traffic loading. Block cracking is caused by environmental conditions and aging pavement.

Figure 3-4 Block Cracking (not in Lowell)

Typical treatment methods include crack sealing, fog sealing, slurry seal, chip seal, or overlay.

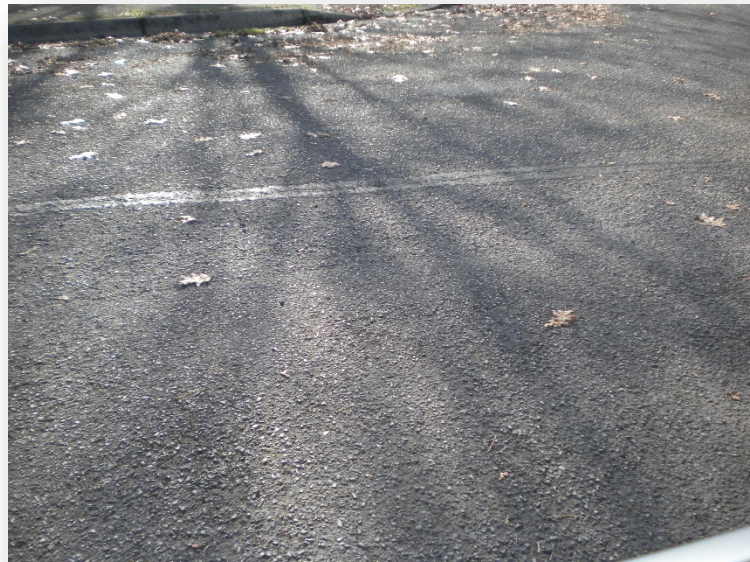
Raveling also is known as "weathering", is the wearing of the pavement binder on the surface. Climate conditions can accelerate the loss of binder and aggregates. New pavement can see raveling start to occur in as little as 6 months after pavement construction due to poor construction methods (inadequate compaction) or oxidation and erosion (water on the pavement surface). The aggregate may be exposed in the sizes of 0.05-inch in low severity cases to greater than ¼-inch in more severe cases.

Raveling is caused by the loss of asphalt binder due to weather, erosion, aging and daily use.

*Figure 3-5 Pavement Raveling on Loftus Ave.*

Typical treatment methods include fog sealing, slurry seal, chip seal, or overlay.

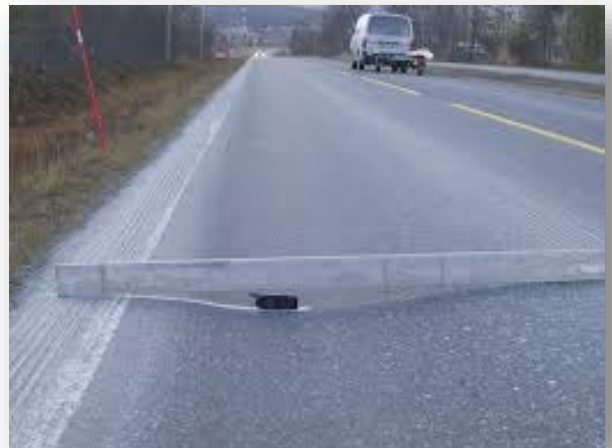
Rutting of the pavement is observed surface depression along the wheel path. This pavement and subgrade deformation are caused by repeated traffic loading and construction method deficiencies. Rutting is more noticeable in rainy weather when standing water can occur. The levels of depression in the wheel path are usually between ½-inch in less severe cases to 2-inches for more severe cases.

Rutting is caused by repeated traffic loading.

*Figure 3-6 Pavement Rutting (not in Lowell)*

Typical treatment methods include milling and overlay.

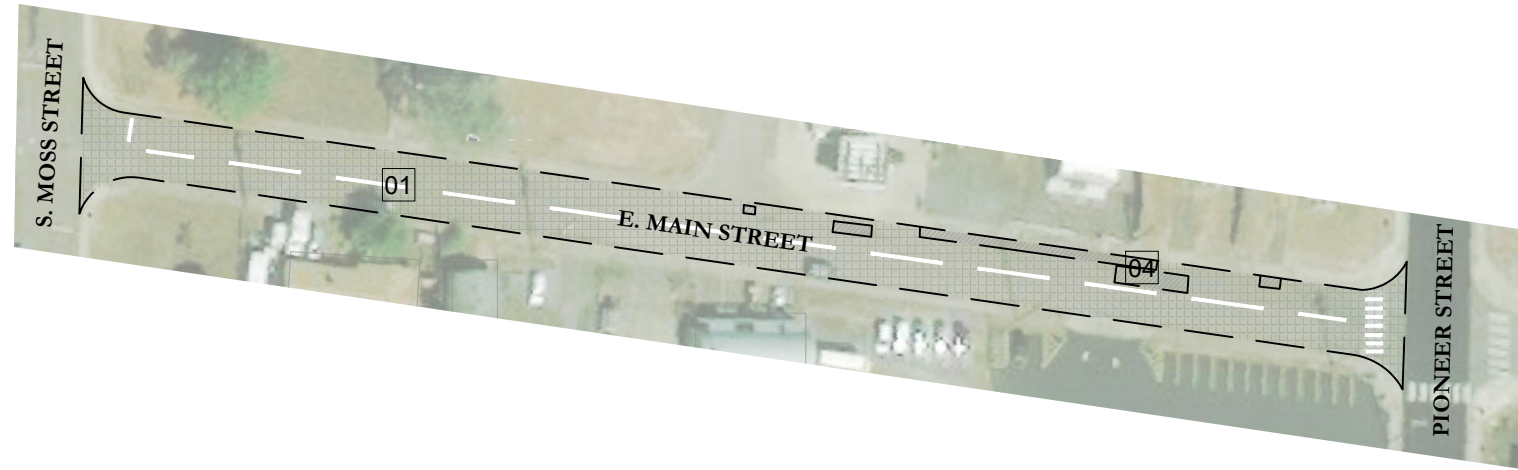
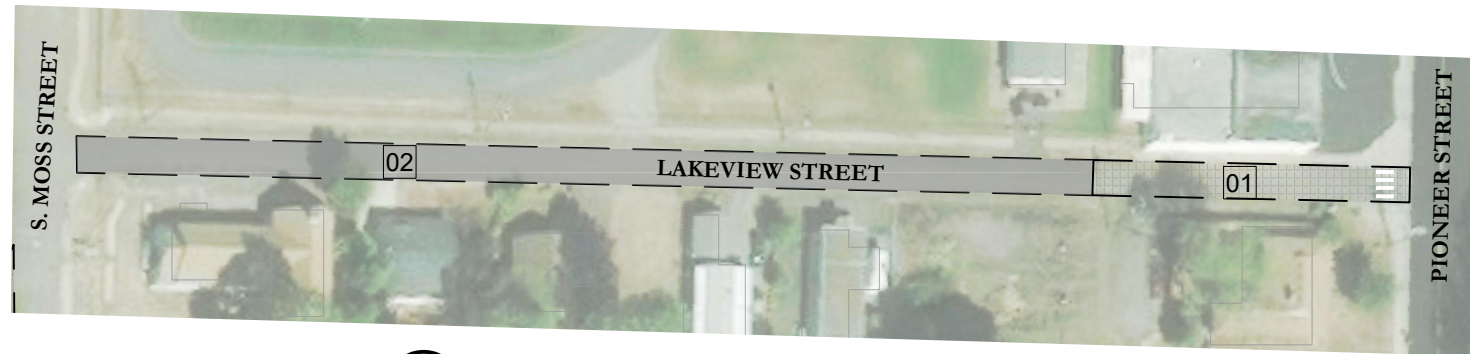
1  
C1

This project is on Main Street. Main Street runs parallel on the northside to the property of the Lowell High School. Main Street was identified by the City as priority projects due to the amount of traffic the street encounter's daily. Observed pavement distress on Main Street includes; severe to moderate alligator cracking, longitudinal cracking, oxidation, aging, and raveling.

Geotechnical investigation, completed July 2018, recommends Main Street be repaired with deep patching in areas of severe alligator cracking combined with a 2-inch grind and overlay of new asphalt pavement. See the project sheet C1 for more information. Below is the overall construction cost estimate for East Main Street improvements totaling **\$119,174.88**.

9. DEEP PATCHES IN AREAS INDICATED SHALL BE SAW CUT AND FAILING AC REMOVED. CONTRACTOR SHALL OVER EXCAVATE 6" OF SUBGRADE AND PLACE GEOTEXTILE FABRIC. BACKFILL WITH AGGREGATE BASE TO DEPTH 2" BELOW SURROUNDING PAVEMENT. PLACE 4" THICK LAYER OF AC TO MATCH EXISTING GRADE.

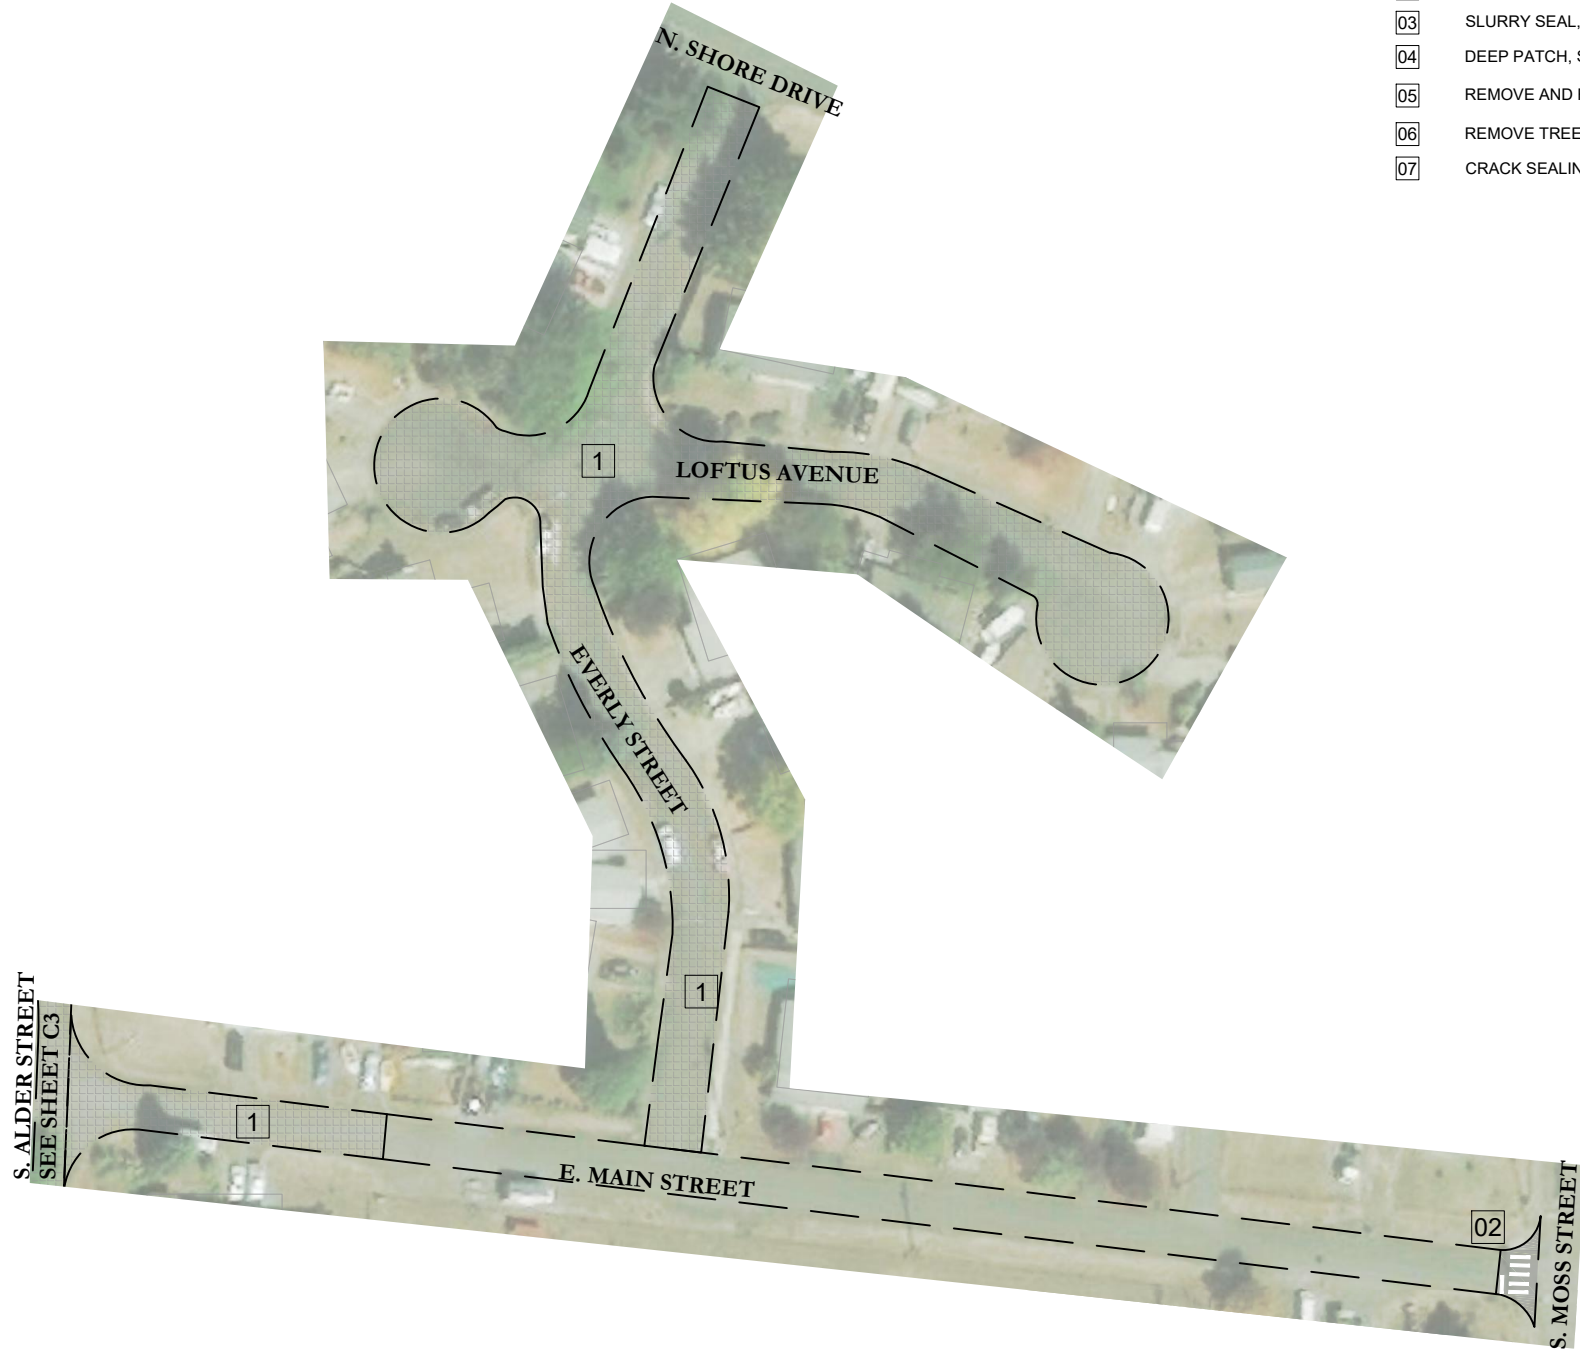
**KEYED NOTES**

- 01 GRIND AND OVERLAY, SEE SHEET NOTES 4-8
- 02 REMOVE AND REPLACE PAVEMENT, SEE SHEET NOTE 12
- 03 SLURRY SEAL, SEE SHEET NOTE 10
- 04 DEEP PATCH, SEE SHEET NOTE 9
- 05 REMOVE AND REPLACE PAVEMENT EDGE, SEE SHEET NOTE 13
- 06 REMOVE TREE ROOTS, SEE SHEET NOTE 11
- 07 CRACK SEALING

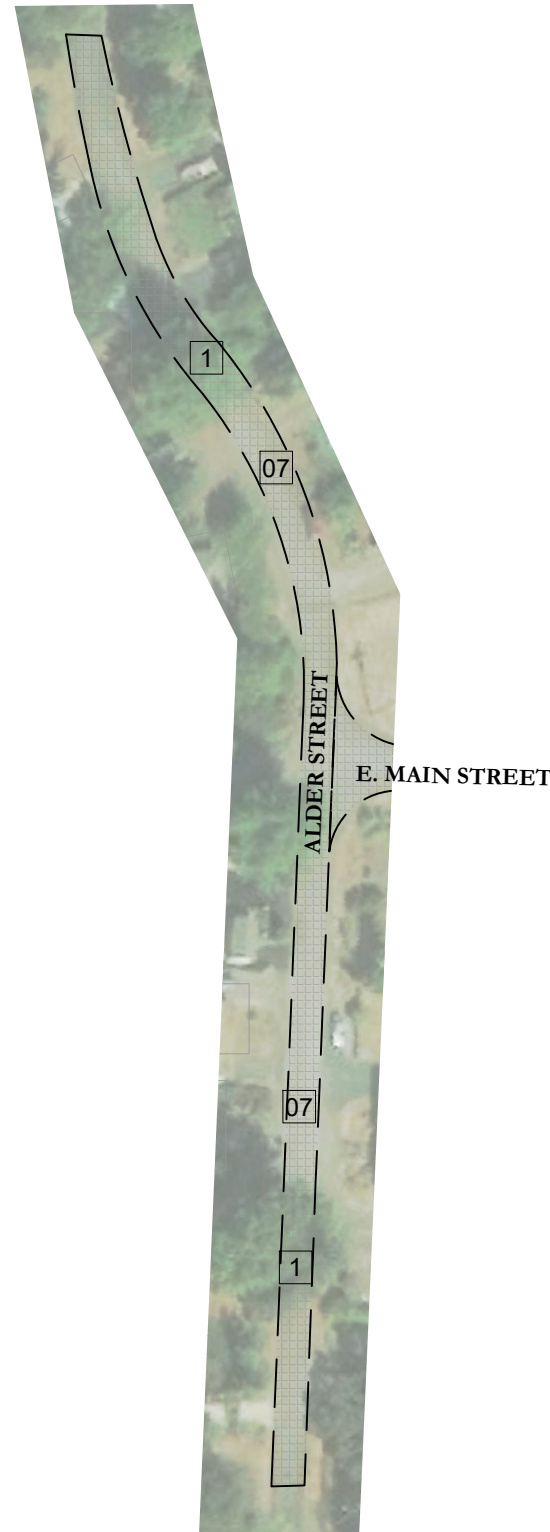
### KEYED NOTES

- 01 GRIND AND OVERLAY, SEE SHEET NOTES 4-8
- 02 REMOVE AND REPLACE PAVEMENT, SEE SHEET NOTE 12
- 03 SLURRY SEAL, SEE SHEET NOTE 10
- 04 DEEP PATCH, SEE SHEET NOTE 9
- 05 REMOVE AND REPLACE PAVEMENT EDGE, SEE SHEET NOTE 13
- 06 REMOVE TREE ROOTS, SEE SHEET NOTE 11
- 07 CRACK SEALING

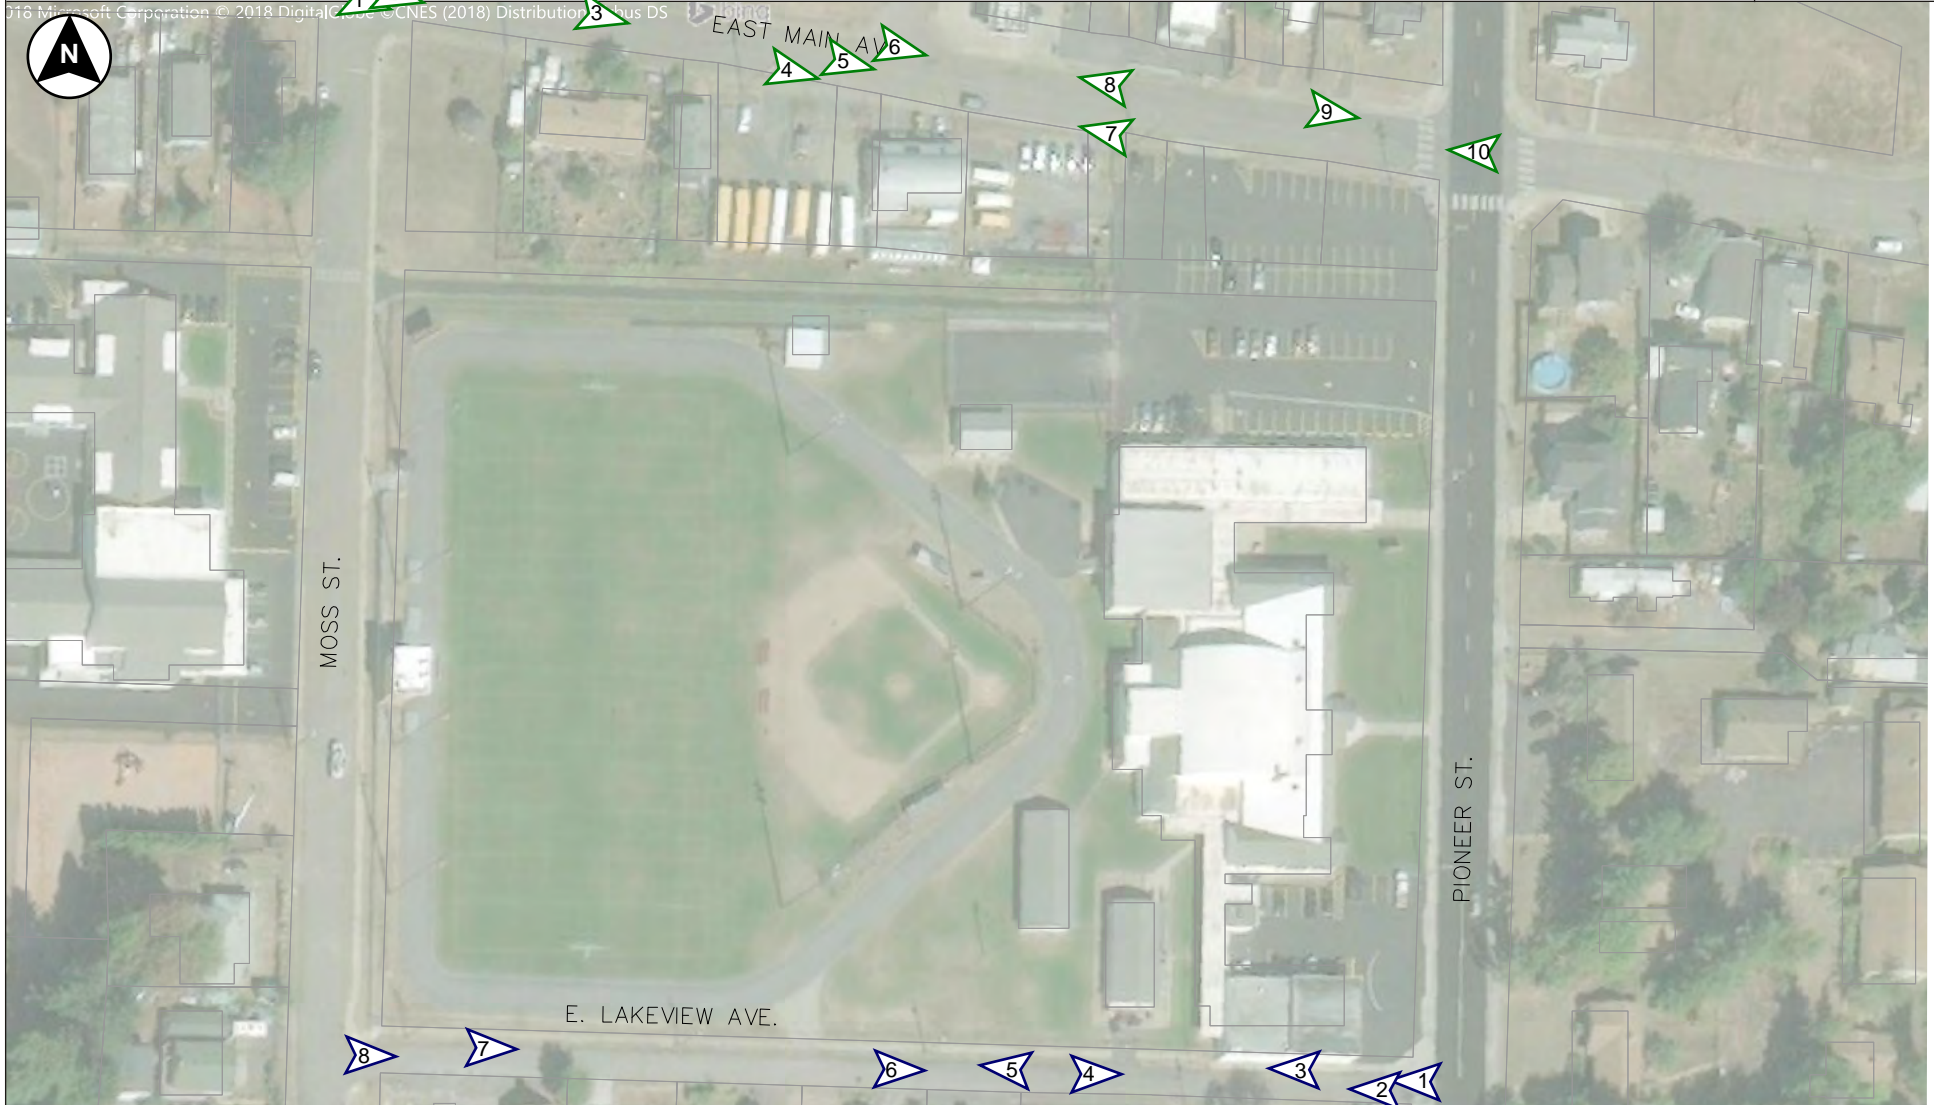
**FIGURE A1**  
**Site Plan**

**CITY OF LOWELL PAVEMENT PRESERVATION - LOWELL, OREGON**  
**Project Number G1804905**

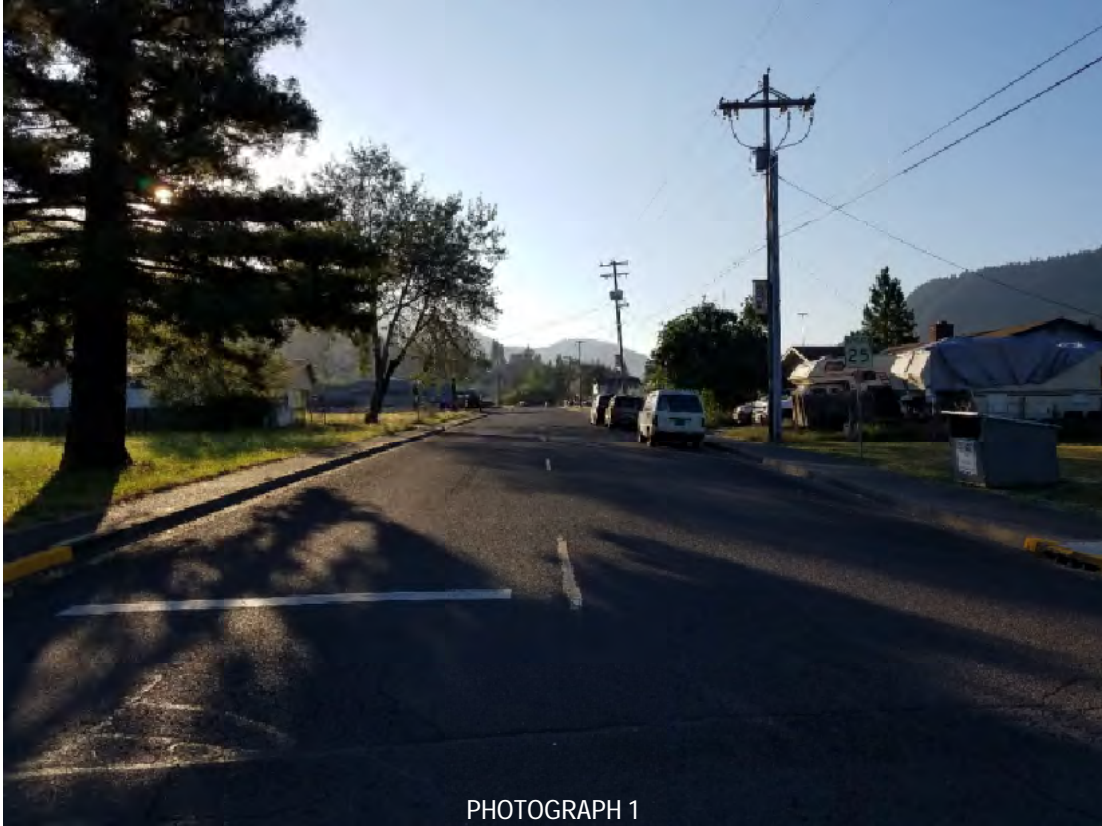
PHOTOGRAPH 1

Photographs were taken at the time of our fieldwork.
